MedSun: Newsletter #40, September 2009

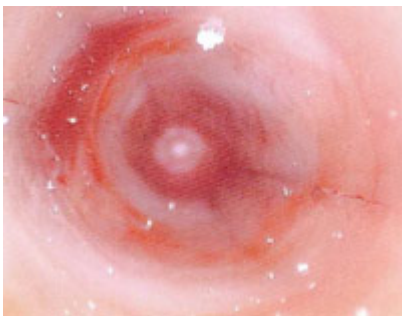
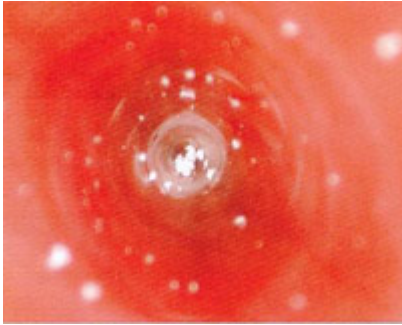
Also, during a case approximately a month earlier, the physician was placing a disposable trocar, model C0116, during a laparoscopic procedure. He noticed multiple white particles falling into the distal tip of the obturator. The white particles collected in the distal tip of the obturator. A photo was taken showing multiple small white particles. The obturator and scope were withdrawn. No particles entered the patient. A different scope was used to proceed with the procedure.

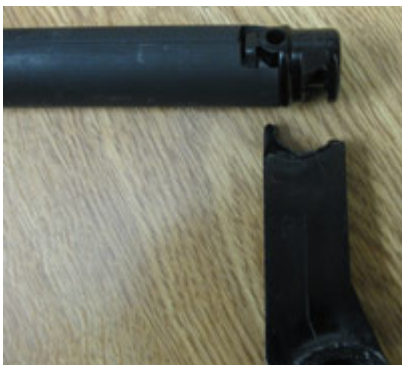
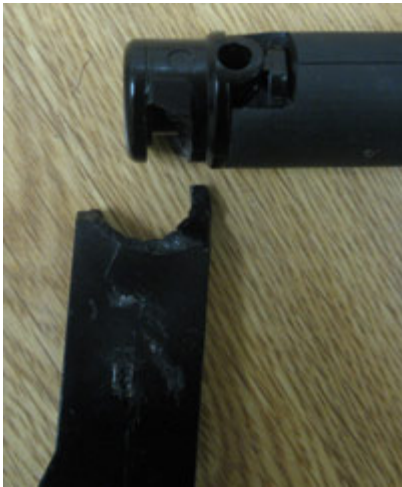
A staff member was retrieving a Zoll CCT defibrillator to use for a transport when the handle snapped away from the defibrillator. This caused the defibrillator to fall and strike the caregiver in the upper leg. The handle broke on both pivot hinges completely separating from the defibrillator. The staff member complained of pain and bruising but did not want to pursue medical intervention. The defibrillator was removed from service for Biomedical evaluation and analysis. This is the third incident of these carrying handles breaking away from this model of defibrillator and the second MedSun report from this facility. The weight of the defibrillator with the battery is approximately 16 pounds.

Manufacturer requesting that handle assembly be sent back to them for analysis. A replacement handle was sent from Zoll.

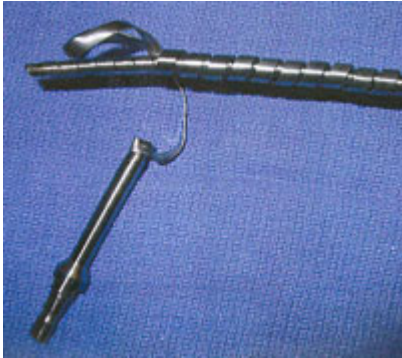
Stryker reamer Size 10 uncoiled while surgeon was reaming bone. Surgeon stopped surgery to remove all pieces of reamer.

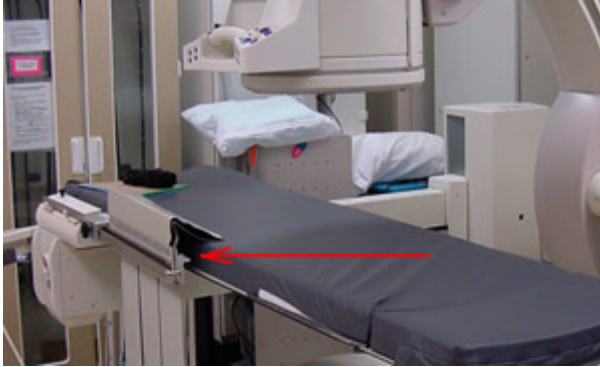
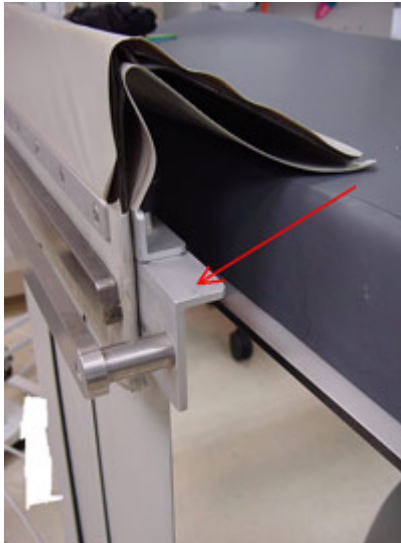
An injury was noticed by a patient care tech assistant. This was noticed after the procedure. There was blood on the blanket. Initially we thought that the IV pulled out after we moved the patient from exam table to stretcher. Examination of the right hand showed about a 1x1 cm skin break/abrasion on the center back of right hand which might have been caused by moving the patient. The hand may have gotten caught in the gap between the table and stretcher. The side bar of the X-ray exam table has a sharp corner.

Usually we cover it with a blanket to prevent such an injury.
